Memorandum

Re: Audit of the 2017 Little York Lake Management Plan

1. Introduction and Scope

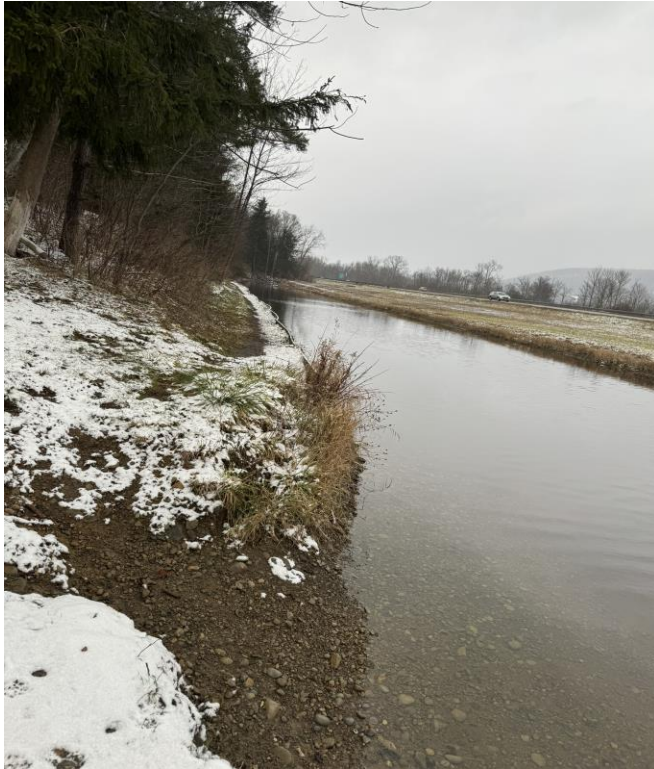
Figure 1. Lake inlet riparian area

Anchor QEA staff conducted a site visit of lake inlets in December 2023. There are opportunities to improve riparian vegetative cover and stabilize streambanks upstream of Little York Lake (**Figure 1**).

- *Survey inlet streams (including application of the Stream Visual Assessment Protocol) to identify potential locations for modification to enhance sediment deposition upstream of the confluence with Little York Lake.*
- *Delineate potentially suitable areas and discuss with NYSDEC, ACOE, USFWS, Cortland County Highway Dept. and other stakeholders.*
- *Conduct public information sessions to educate the community and solicit feedback.*
- *Continue efforts to implement recommendations of the 2017 Princeton Hydro report for BMPS, including both upstream BMPs and measures within Dwyer Park.*

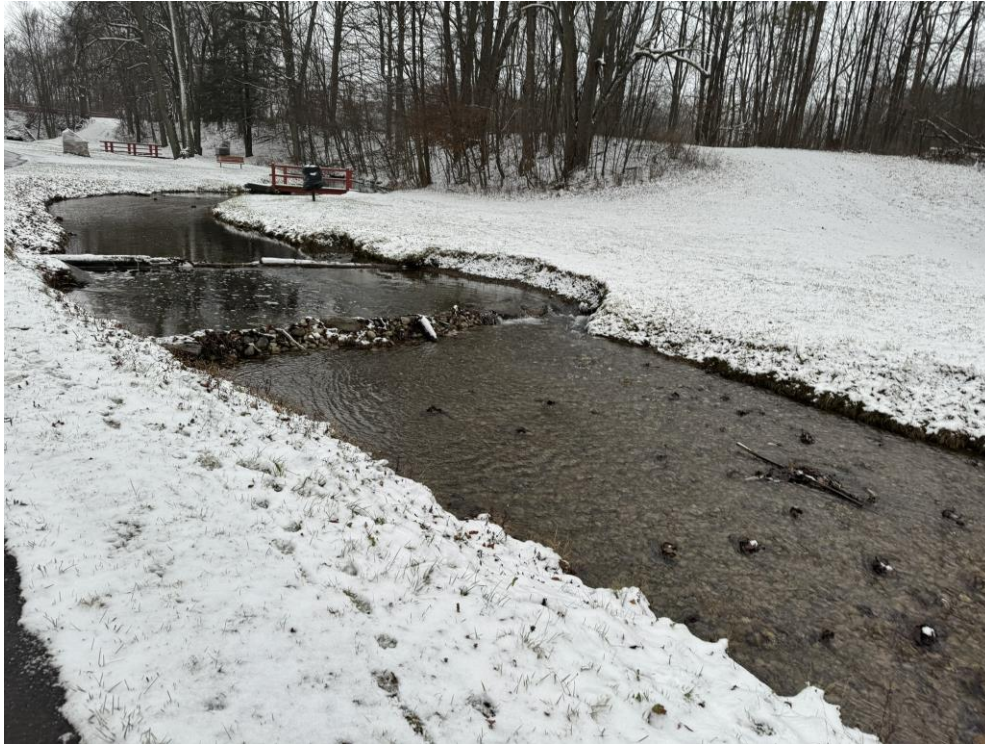
Figure 2. Existing in-water structures within Dwyer Park

In addition to upland BMPs, there may be opportunities to install sediment basins within streams as they flow through Dwyer Memorial Park. Nature-based methods to slow velocity of sediment-laden inflows and allow sediment to settle from the water column can advance the goal of reducing sediment and sedimentation. Routine maintenance and removal of sediment deposits upstream of the lake can be more cost-effective than lake dredging, and many be within local resources for equipment, trained personnel, and disposal options. As shown in **Figure 2**, there are remnants of in-water structures that appear to have been in place for decades. Note the accumulation of deposited materials.

Any planned modification to the streambed and riparian areas within Dwyer Park must consider the many ways that the parkland is used. Access to the stream for recreation benefits visitors of all ages. Vegetated banks help mitigate flood risk and provide shade and refuge to the aquatic community. Community discussion of ways to improve the stream corridor and other areas within the Park would provide a forum for environmental education,
